# Hotels

## Preventing Avoidable Loss from Wind-Driven Rain

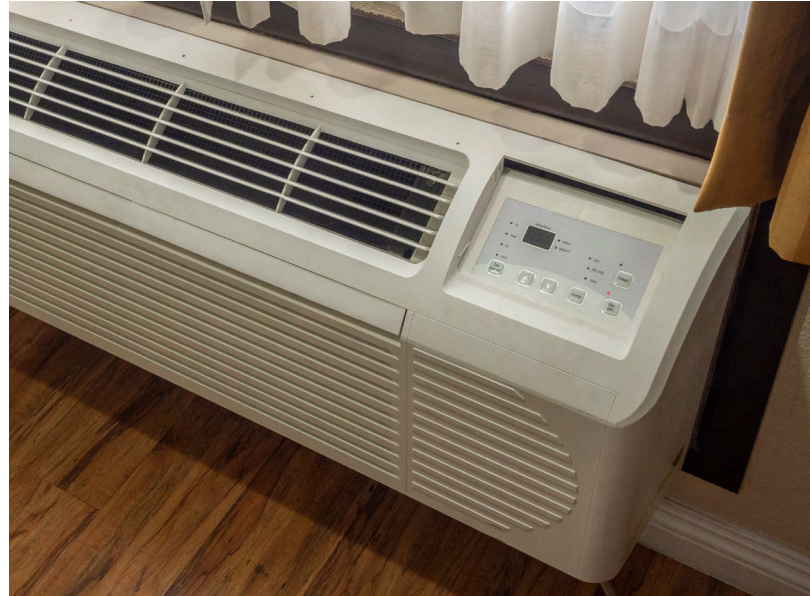
Package Terminal Air Conditioners (PTAC), which are individual air conditioner units found in hotel rooms, are inserted directly into an opening in an external wall and extend into a room's interior. These units have multiple components that can act as a path for water entry into a room during wind-driven rain events.

### A. Orientation

The tilt is critical to reducing water entry for units with external drains. Such units should be installed with a minimum slope of 2 degrees to the outside wall (per manufacturer guidelines). This can reduce water entry by 90%. Measure the tilt of the unit at several locations along the bottom of the sleeve to ensure it is consistent. If the unit was installed without the proper tilt, hire a licensed HVAC (heating, ventilation, and air conditioning) contractor that specializes in PTAC units to inspect and provide additional guidance.

### B. Weather stripping

Look at the weather stripping that sits between the PTAC unit and sleeve to ensure it has been installed correctly and consistently—otherwise, this can increase the risk of water entry. If damaged, new weather stripping may be required. Work with the manufacturer to determine whether this can be fixed by the maintenance crew or if hiring a licensed HVAC contractor is necessary.

### C. Internal drains

Installations that use internal drains for PTAC units can reduce water entry by approximately 95%. Ensure the internal drainpipe size is adequate and water is flowing freely in order to handle high water volume, as 1 gallon of water per unit can flow through a pipe every 4 minutes during heavy rain. If the unit has an inadequately sized drain, work with the manufacturer to see if there are any mitigation options. Otherwise, a new unit with a properly sized drain may be required.

### D. Caulking

Examine caulking around PTAC units to determine if any damage or improper caulking has occurred. Repair with a manufacturer-approved caulk as necessary.

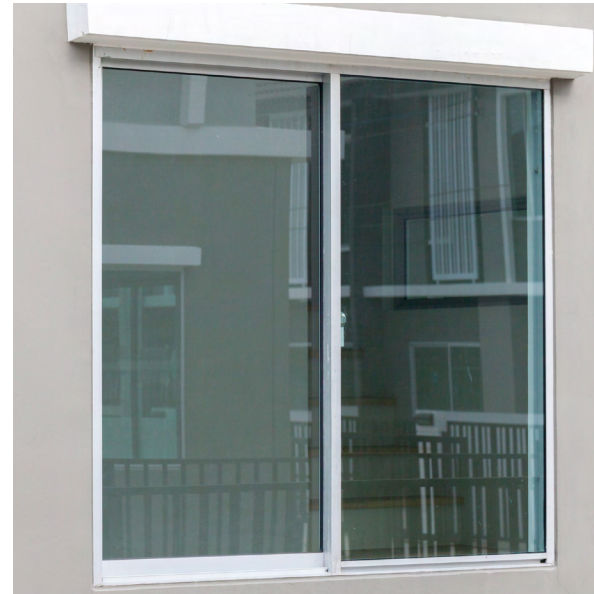
### **What is glazing?**

The mechanism that holds glass in an opening while providing protection against water intrusion and temperature expansion. There are two types of glazing:

- Wet glazing - a sealant installed over a backer rod that sits in the frame itself. Sealed with a wet seal (a type of caulk).
- Dry glazing - uses a preformed rubber gasket.

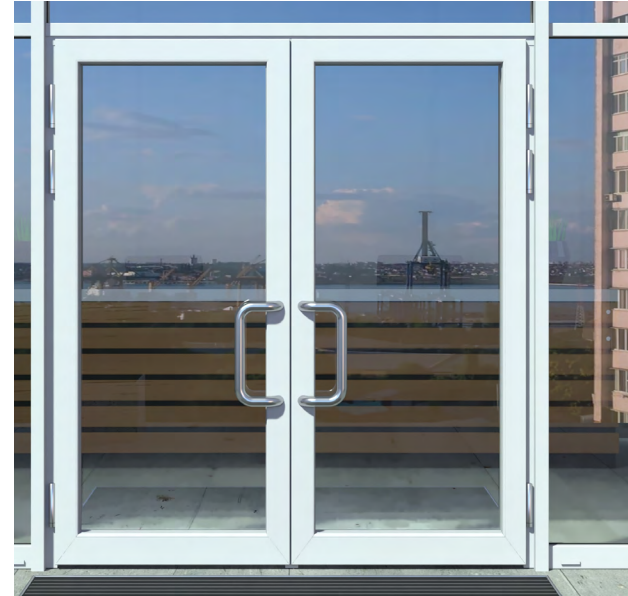
### **SWINGING GLASS DOORS:**

Swinging glass doors are typically used on first floor entryways and for access to outdoor gardens or event spaces. These systems are typically not rated for water penetration resistance because they have a low threshold protected by a compressed gasket. However, it is typical to see the gasket of the threshold become uncompressed, which allows for water penetration. A rain guard and sweep gasket should be installed at the bottom of the exterior side of the door.

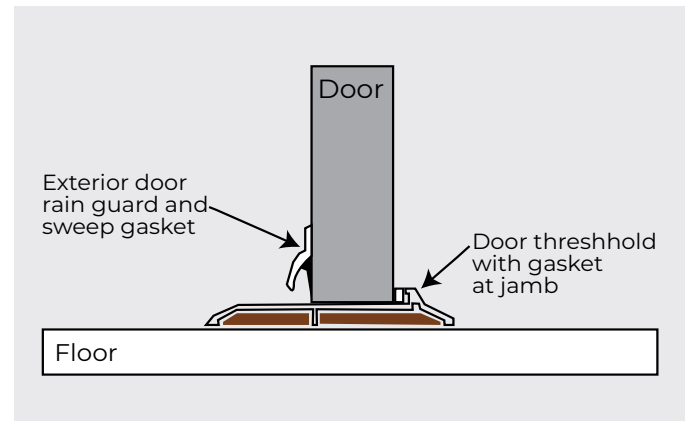
Water intrusion most often occurs between the door and the threshold, as well as where the two doors meet. It must be assumed that water intrusion will occur here; therefore, these doors should only be used in ground floor areas that are not above interior spaces and where the leak can be mitigated.

### **A. Door-to-door**

Gaskets where two doors meet should sit flush up against one another providing a tight seal. If there is damaged, wavy, or missing gasketing, repair or replace as necessary.

### **B. Exterior door rain guard and sweep gasket**

A rain guard and attached sweep gasket can be attached to the exterior side of the door to resist water penetration below the door. It should be properly installed to manufacturer specifications to help direct water away from the interior. If damaged or missing, replace the guard and gasket.

### **C. Threshold**

Check to make sure the compressed gasket is form-fitted to the door jamb. If necessary, work with the door manufacturer to replace the compressed gasket so that it is form-fitting and creates a watertight seal.

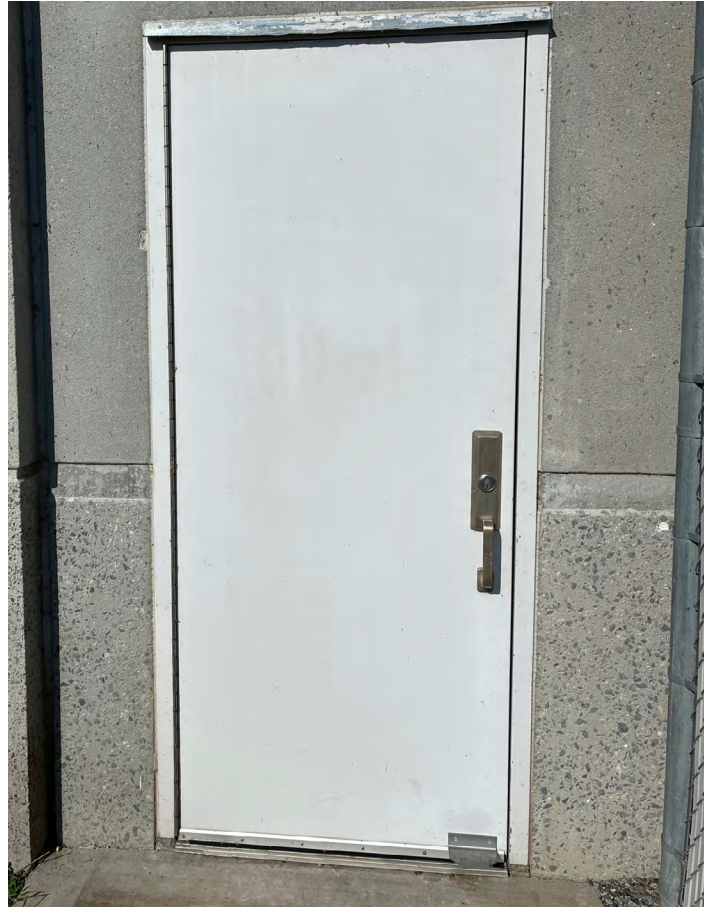
## **PERSONNEL DOORS:**

Personnel doors with exterior access are typically used for stairwells accessing the roof, mechanical rooms, including penthouses, utility spaces, loading areas, and other similar areas of hotels. It is not uncommon to see sections of these doors fitted with glass. Since these doors are widely used for staff access, little maintenance is conducted and weatherproofing for these doors may be limited. They typically rely on sealants/caulking between the door jamb and door frame, continuous gasketing installed at the perimeter of the door, and have a gasket at the door threshold. Personnel doors located on hotel roofs are particularly vulnerable to water intrusion.

### **A. Door jamb and frame sealant/caulking**

Inspect for any gaps, missing, brittle or excessively aged sealant/caulking. Repair with a manufacturer-approved caulk.

### **B. Exterior door gasket**

Inspect for continuous non-compressed gasketing that form-fits to the frame. Replace any damaged, excessively aged, or missing gaskets.

### **C. Threshold gasket**

Inspect for continuous non-compressed gasketing that form-fits to the threshold of the door. Replace any damaged, excessively aged, or missing gaskets. Note: Hollow doors in high traffic areas that utilize equipment can damage this gasket and should be monitored more frequently.

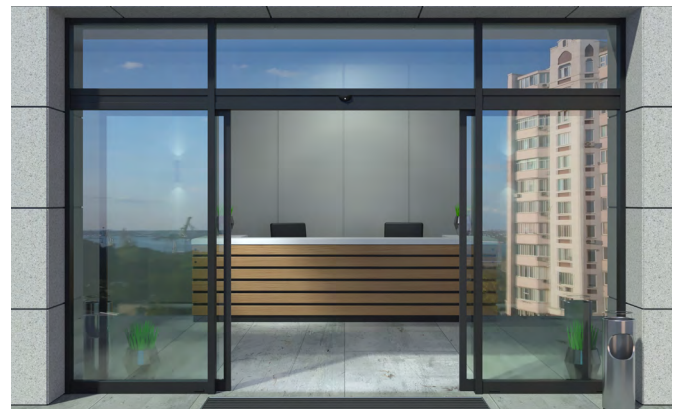
Manual sliding doors are typically used for balconies and may be on the upper levels of the building. They include a fixed frame that has a threshold, head, and side jambs that include a sliding glass door within. The threshold can be depressed into the floor slab allowing the threshold to be ADA accessible. This detail leaves the interior spaces more susceptible to water intrusion. These doors rely on a gasket that sits between the sliding door and the fixed frame perimeter to keep a watertight seal.

Automatic sliding doors can be found at ground level typically around the hotel lobby and pool access. They can be single doors that open in one direction, or can be a dual system where the doors slide open in different directions. In both cases, there is a potential for water intrusion through the recessed threshold, frames, and where the door meets the frame or other doors. Some automatic sliding doors have telescoping panels where

several smaller individual panels move collectively to create an opening. In this case, the additional panel-to-panel points can contribute to a higher risk of water intrusion.

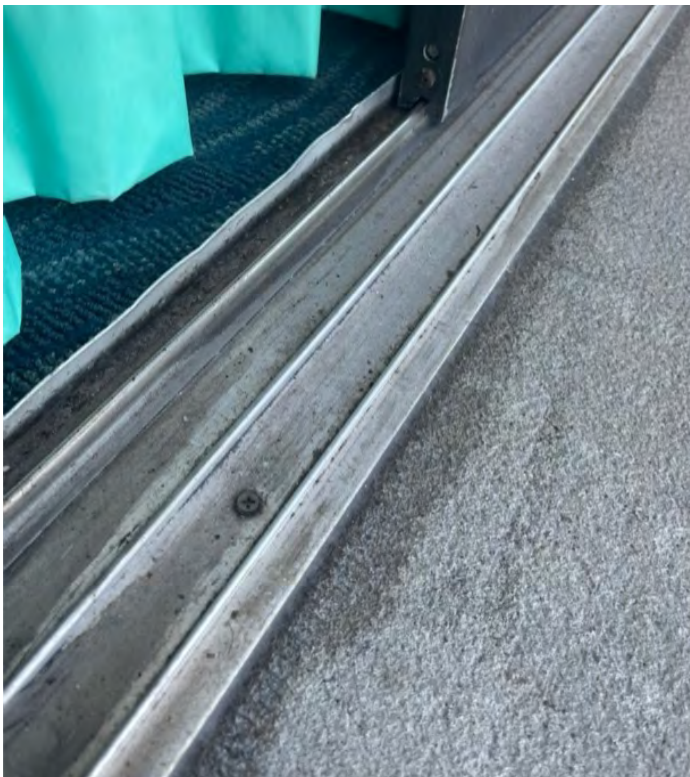
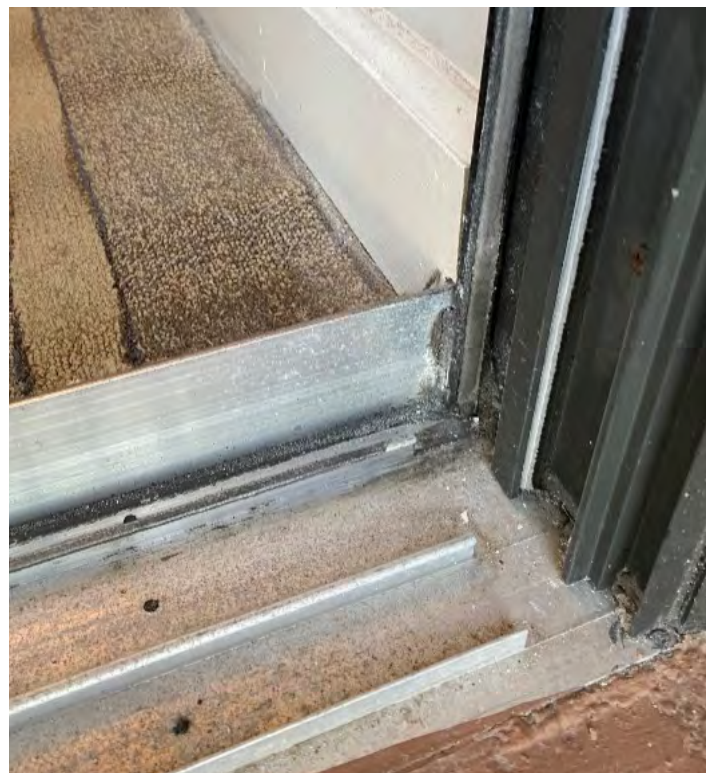
In both cases, there are typically brush gaskets that sit between the fixed and sliding part of the door, between doors (telescoping), and at the bottom of the door near the threshold. These locations are at higher risk for water intrusion; water at this location needs to be drained at the threshold frame below.

### A. Door jamb and frame sealant/caulking

Inspect for any gaps, missing, brittle or excessively aged sealant/caulking. Repair with a manufacturer-approved caulk.

### B. Door perimeter gasket

Inspect for continuous non-compressed gasketing that form-fits to the threshold of the door. Replace any damaged, excessively aged, or missing gaskets.

### C. Door-to-door (telescoping)

Gaskets where two doors meet should sit flush up against one another providing a tight seal. If there is damaged, wavy, or missing gasketing (rubber or brush), repair or replace as necessary.

### D. Threshold and/or guiding rail/track

The threshold and/or guiding track is a source for water intrusion. Inspect the door to ensure it is properly operating in the threshold or connected to the track per manufacturer specifications. If a brush gasket is located at the bottom of the door, make sure it is not damaged or missing. Repair or replace as necessary. In some cases, an additional lip can be added to the threshold toward the interior of the guiding rail/track. This can provide additional protection against water intrusion.

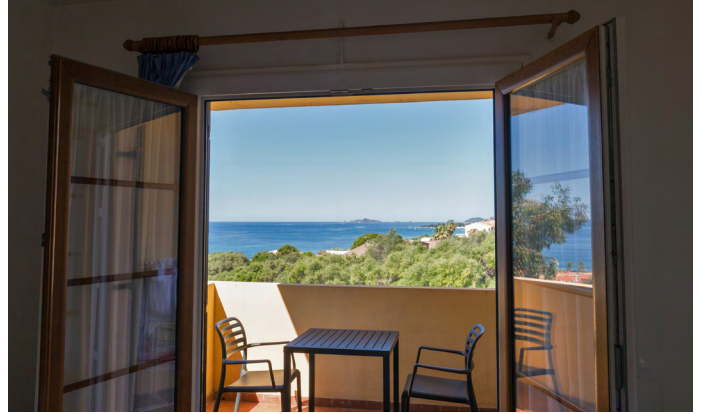
## **TERRACE DOORS:**

Similar to sliding doors, these doors are typically found in hotel rooms with typical balconies or Juliet style. With a fixed frame around the entire perimeter of the door, they perform well for water penetration. The threshold is often raised to allow for the removal of water. While this is important to mediate water intrusion, this creates issues for ADA accessibility. Alternatively, the threshold can be depressed into the slab of the floor, but this can cause problems with water penetration. Additionally, when two terrace doors meet, it provides an additional point of entry for water, which should be mitigated with a gasket.

### **A. Door jamb and frame sealant/caulking**

Inspect for any gaps, missing, brittle, or excessively aged sealant/caulking. Repair with a manufacturer-approved caulk.

### **B. Threshold gasket**

Inspect for continuous non-compressed gasketing that form-fits to the threshold of the door. Replace any damaged, excessively aged, or missing gaskets.

### **C. Door-to-door**

Gaskets where two doors meet should sit flush up against one another providing a tight seal. If there is damaged, wavy, or missing gasketing, repair or replace as necessary.
