Roof Protection Begins at the Edge

METAL EDGE FLASHING INSTALLATION ON LOW-SLOPE ROOF SYSTEMS

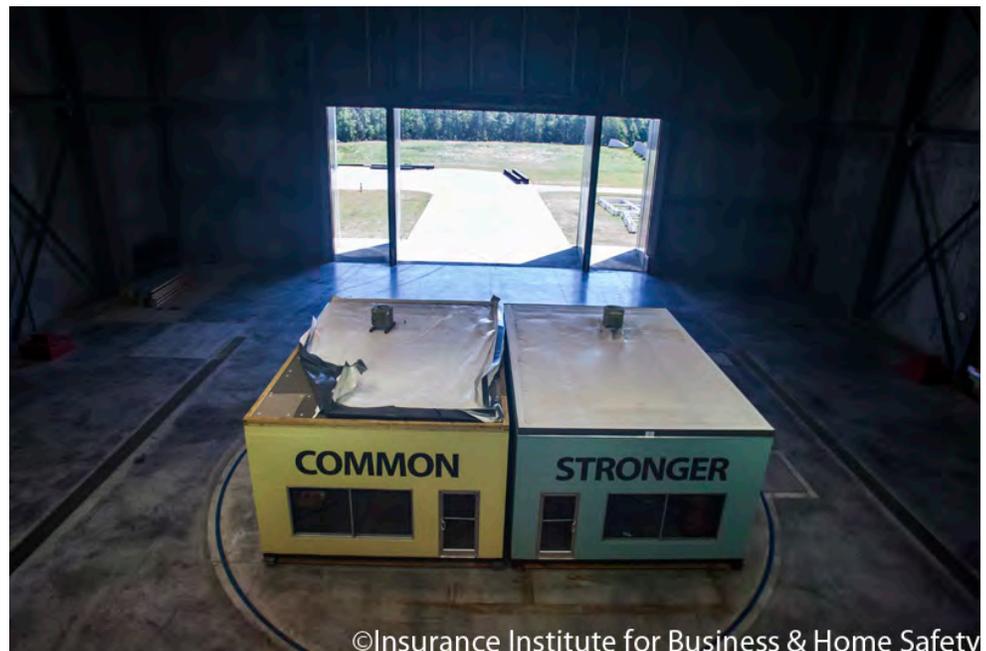
IBHS testing of common versus stronger construction practices for small retail/service masonry structures. To see the complete test and for more information on the IBHS commercial high wind demonstration, visit www.disastersafety.org/high_winds/commercial-high-wind-test-resources/.

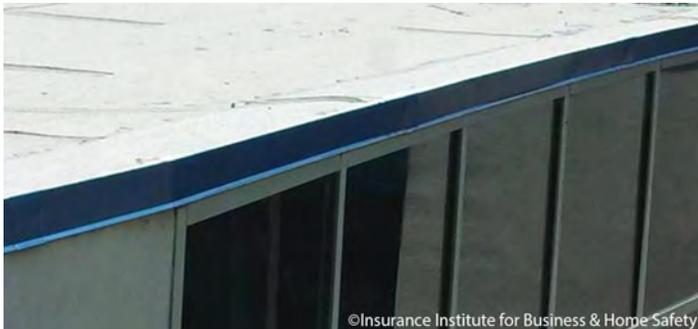
Most low-slope and flat roofs have roof cover systems that terminate under the edge flashing system. As shown in the photo above, the edge flashing (finished in blue) can be found where the roof meets an exterior wall.

Metal edge flashing can be found along the perimeter of a building where the roof meets an exterior wall, and includes a metal fascia that extends down the wall several inches. This is where the roof cover terminates at the edge of the building, and is the roof cover's first line of defense against wind damage.

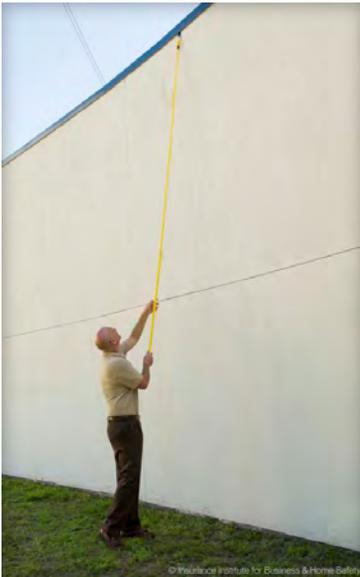
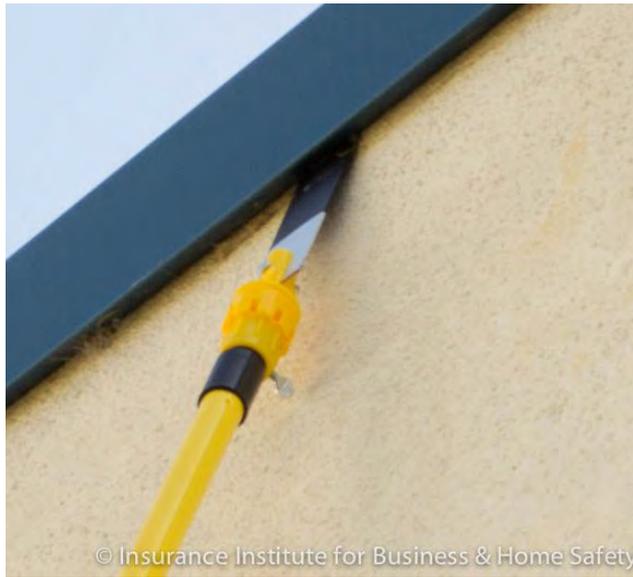
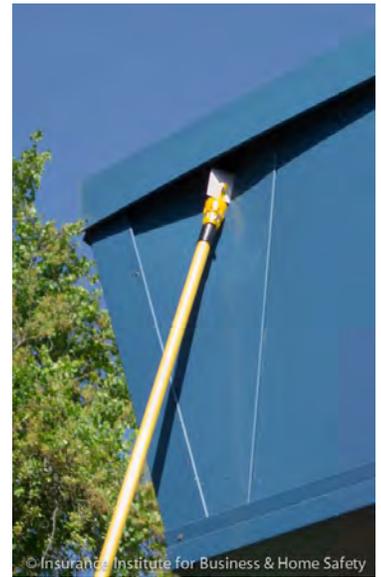
A flashing inspection tool developed by IBHS allows an inspector to physically check the flashing from the ground.

While it's best to conduct a physical inspection of the flashing system from the top, roof access is not always possible. One alternative is a simple method developed by IBHS for checking edge flashing securement from the ground, using a telescoping pole with a piece of 1 ½ in. wide metal on the end that can be used to test the tightness of the fascia by rotating the pole (*shown on the next page*). If the fascia pulls out when the metal piece is turned between the fascia and the wall, the flashing probably is loose and may need to be replaced.

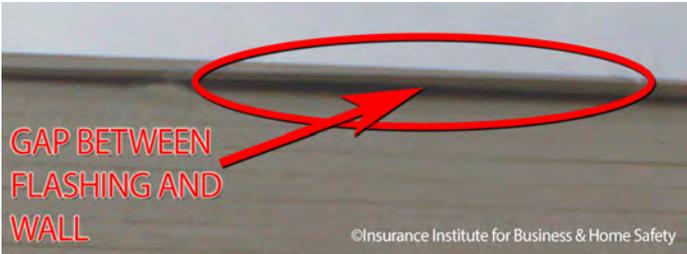
Look for gaps between the flashing and the wall when inspecting edge flashing.

- Gaps, bowing or waviness between the fascia metal (the part of the edge flashing running down the face of the wall) and the wall, as shown in the following photo.
