Evaluating Wind Resistance of Single Ply Membrane Roof Covers on Commercial Buildings with Steel Decks

Single Ply Membrane (SPM) Roof Covers

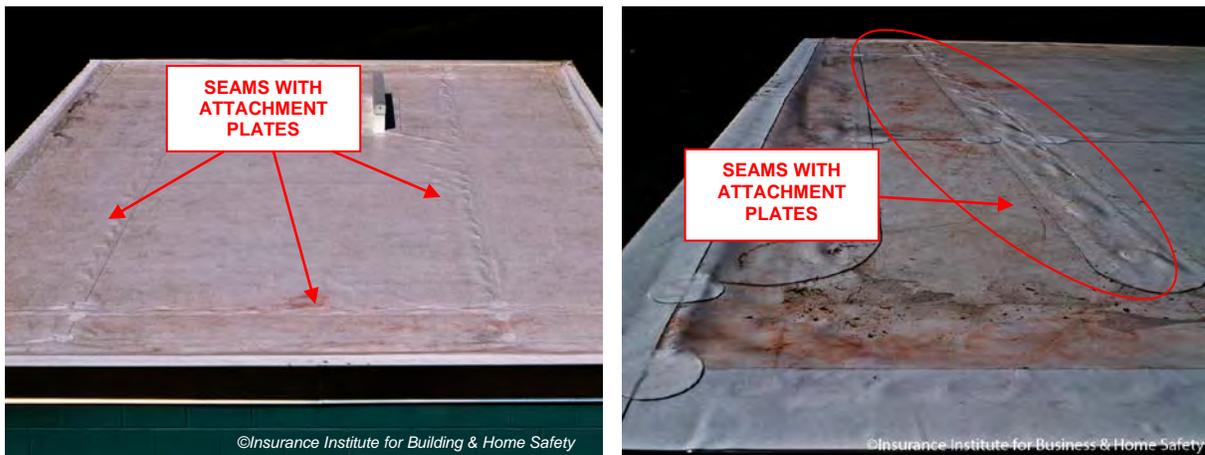
Figure 1. Mechanically attached TPO roof membranes with indications of seam attachment plates.

Mechanically Attached SPM roof covers have their membranes anchored to the steel deck using metal or plastic plates, like large washers, and long screws. The plates are located along overlapping membrane seams and installed using screws that penetrate through insulation boards and engage the deck below. This type of membrane installation can be identified by checking seams for signs of anchorage plates, as shown in Figure 1. Typical high wind failures include the SPM tearing over the seam plates, if the sheets are too wide and/or if the seam plates are spaced too far apart. TPO and PVC membranes have seams where the two overlapping sheets are heat welded together to form a mechanical bond. Batten bars are narrow plastic or metal bars that can also be used to fasten the SPM to the deck, and they will be covered with a membrane. Newer mechanically attached EPDMs use double-faced tape to attach seams, while older installations use adhesives or single-face tape, and therefore, are more prone to failure.

Yes	No	
		1a. Are plates present along the seams of the roof membrane sheets? If so, the roof cover is mechanically attached. If it is difficult to see the plates, gently rub your foot along the seam to identify the plate locations. Next, to determine wind resistance, measure the spacing of the seam plates in the interior/field sections and note the sheet width. Then, compare the sheet width and plate spacing with that of seam plates in the perimeter areas to answer the following questions: Does the perimeter area have more plates along the seams? Were reduced-sized membrane sheets used in the perimeter areas? Are there intermediate rows of plates or batten bars covered with strips of membrane?
		1b. Using the notations made above, determine whether, in comparison to the perimeter areas, there are additional rows of plates or batten bars in the corners to provide additional anchor plates and screws?

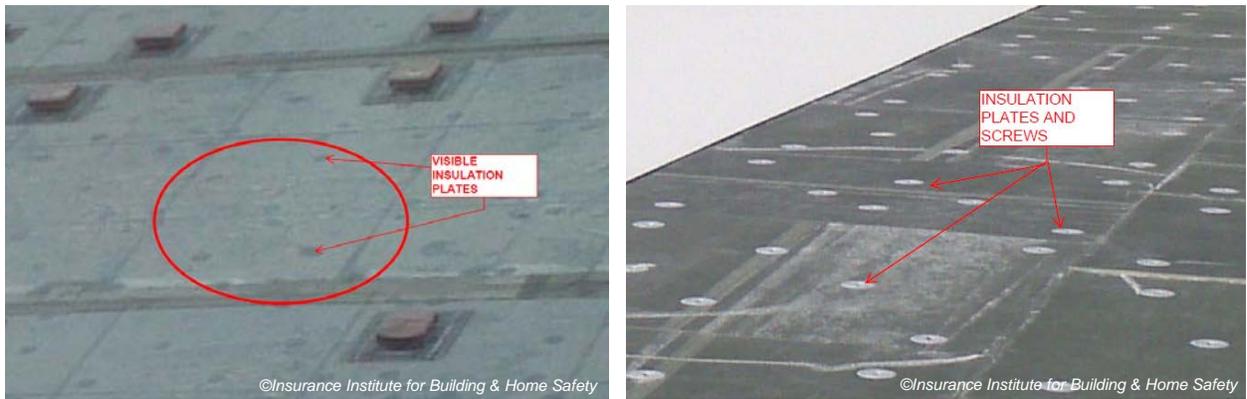
Figure 2. Adhered EPDM with insulation plates (left) and TPO cover removed exposing insulation plates (right).

Adhered SPM roof covers include a contact adhesive that attaches the membrane to a substrate, typically insulation boards. The boards are attached with plates and long screws, which engage the steel deck below. This type of membrane installation can be identified by looking for indentations in areas away from laps, where the membrane is pulled down over anchor plates used to attach the insulation, as shown in Figure 2 (next page). Typical high wind failures include SPM delaminating from insulation board; delamination of insulation board facer; or an inadequate number and spacing of plates and screws anchoring insulation to the deck.

2. No plates will be present along membrane seams if the roof cover is a fully adhered SPM. However, insulation plates may be visible. If it is difficult to see the plates, gently rub your foot over the membrane to identify the plate locations. If the roof deck below is exposed, it may be easier to count the fasteners from inside. Either way, the goal is to determine if the insulation is anchored to the deck with a higher density of plates and screws in the perimeter and corners than in the interior. To determine this choose a corner area of approximately 3 ft. x 3 ft. and count plates. Do this for a perimeter area away from the corner, and also for a 9 ft. x 9 ft. area in the interior of the roof. Divide the number of interior fasteners by 9. For wind resistance, the greatest number of fasteners should be located in the corners, followed by the perimeter and the fewest plates in the interior. Is this the case?
