## Benefits of Properly Maintaining Roof-Mounted Equipment

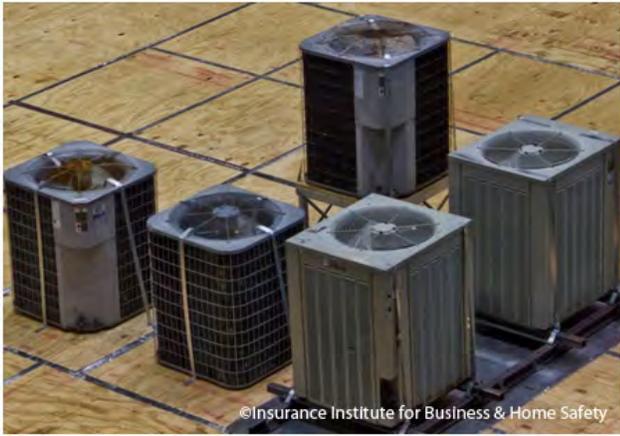
*Secure AC units like those shown above in order to reduce the risk of damage to the equipment during high winds.*

Fans, as shown in the split-system AC units pictured here, are an integral part of all air conditioning systems. Fan blades operate most effectively when they are well balanced. When the blades are unbalanced, the unit will vibrate and this may cause screws and other parts to loosen. An unbalanced fan reduces efficiency and compromises the unit's secure attachment.

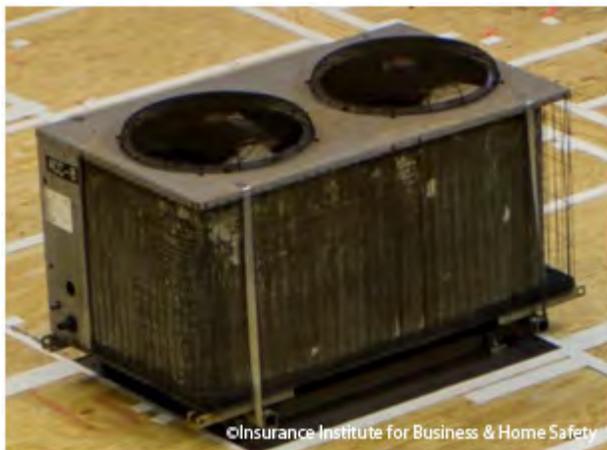
*The AC unit above shows wear from corrosion and deterioration, which can cause parts of the unit to become airborne during high winds.*

Because rooftop equipment is exposed to all weather elements, it is vital to maintain the unit’s exterior and make sure it is securely attached. Corrosion and deterioration, as shown below, are the most common problems and can allow panels or other parts to become airborne in the event of high winds.

- ✓ Inspect for rusted metal panels, screws and metal flashing on curbs, and replace as soon as possible.
- ✓ Inspect around the unit’s connection to the curb it sits on. Check for any visible signs of potential leaks; these can be repaired using various roof sealants and caulks that are readily available.
- ✓ If it is suspected that a water leak has occurred, the curbing itself should be inspected for rotting and replaced if needed.

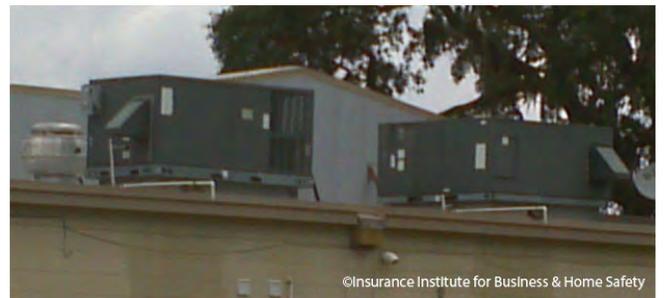
*Regular inspection of commercial rooftop equipment, as shown above, is critical in preventing significant damage during severe weather.*

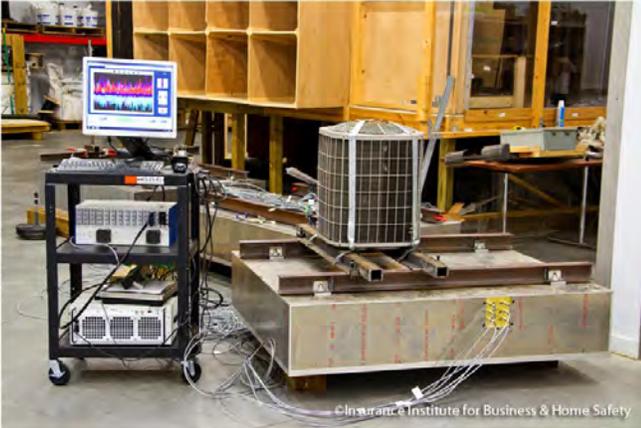
*The picture above shows some of the tools that allow IBHS to measure various loads on AC units during tests.*

The overall approach of the research continues to be the use of actual rooftop equipment and objects that represent typical shapes of rooftop equipment. This includes mounting the equipment on force balances that allow IBHS to measure various loads on the units. The results of these tests will be used to:

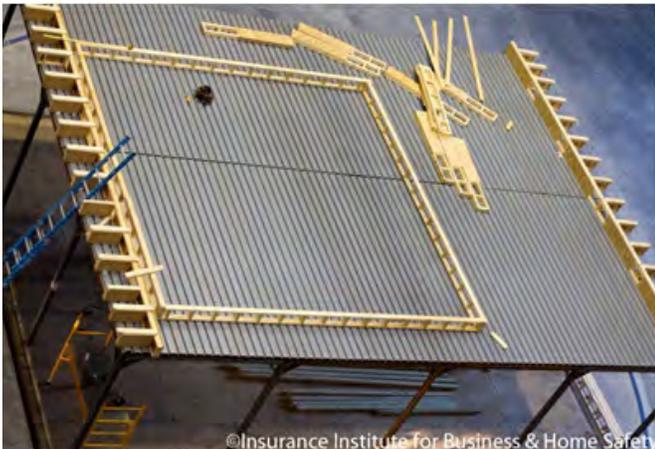
*Construction of the commercial building used during tests on rooftop equipment at the IBHS Research Center.*

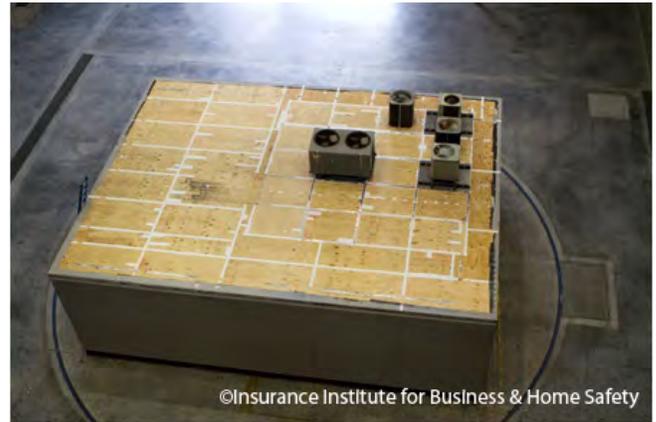
*AC units in the above picture were used during recent tests, which included a specific focus on wind load specifications and future prescriptive guidelines for anchorage.*
